# **Spot Safety Project Evaluation**

Project Log # 200505109

Spot Safety Project # 08-95-220

**Spot Safety Project Evaluation of the Standard Flasher and Left Turn Lanes Installation at the Intersection of SR 1001 (Lemon Springs Rd) and SR 1146 (St. Andrew's Church Rd) in Lee Co.**

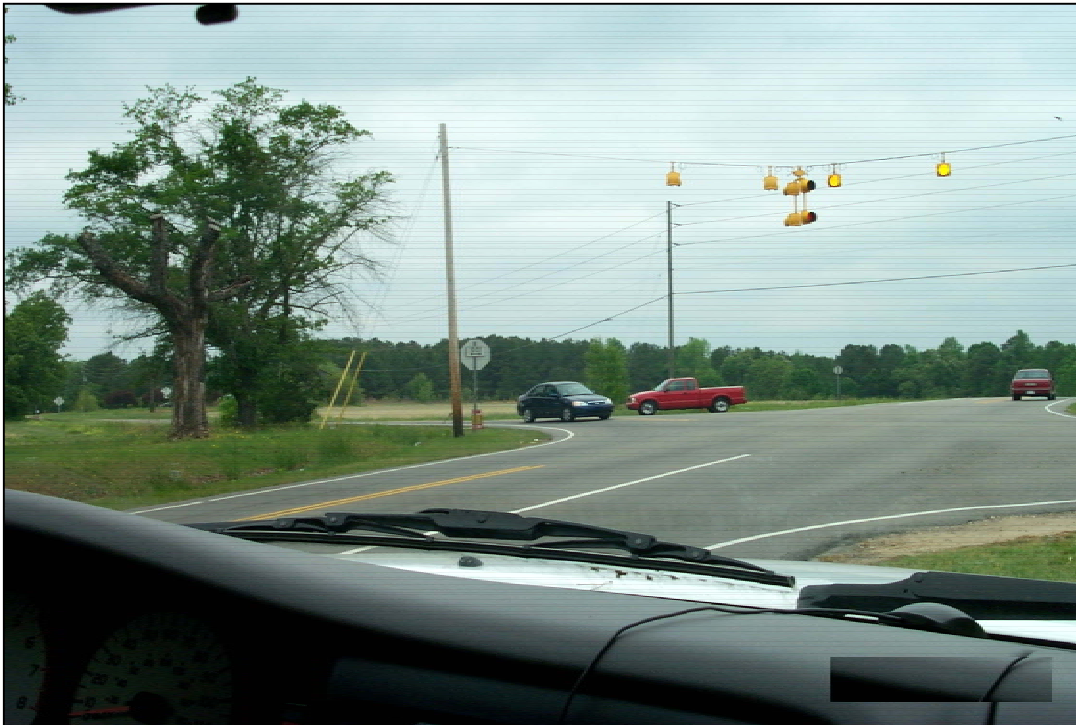
Picture 1.

Through observation, vehicles that were attempting a maneuver from SR 1146 eastbound stopped a

distance of 10 to 15 feet away from SR 1001 (Picture 1). Since the cross-section was already increased by one lane, a vehicle stopping this far from the intersection may unknowingly add another travel lane to cross leaving it exposed in the intersection for a longer period of time.

While driving along SR 1001 it was observed that dashed white lines existed at other intersections along the route to delineate the edge of the travel lane. This may help drivers determine a proper stopping distance to allow for safer crossing of SR 1001 if the dashed lines were placed at the treatment intersection.

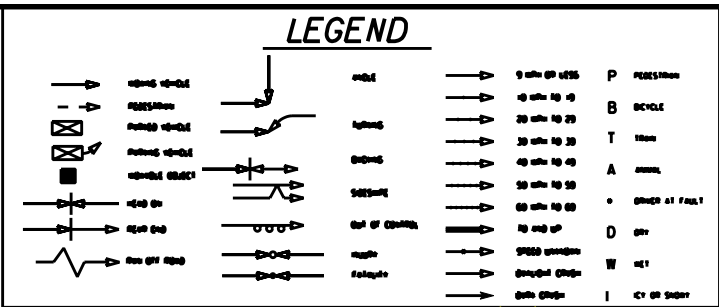
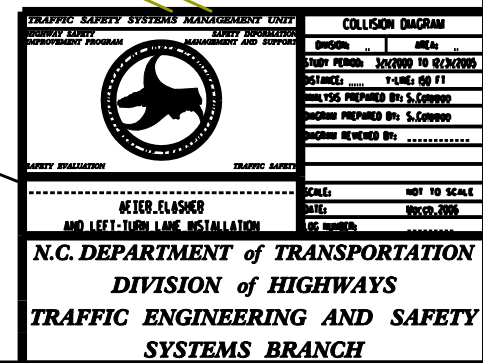
Lee County  
Treatment Site - TotalCrashes  
After Period  
March 1, 2000 - December 31, 2005  
(5 years 10 months)

SR 1001 (Lemon Springs Rd)  
55 mph

SR 1146 (St. Andrews Church Rd)  
45 mph

Standard Flasher

Referencing the collision diagrams and Table 2 it shows the problem of rear end collisions was addressed and decreased with the installation of left turn lanes along SR 1001. However, the tables and diagrams show an increase in frontal impact crashes (southbound and eastbound combination).
